TECH REPORT

SUBJECT: BOEING 787 MATERIALS FLAMABILITY

B-2A, T/N 89-0127

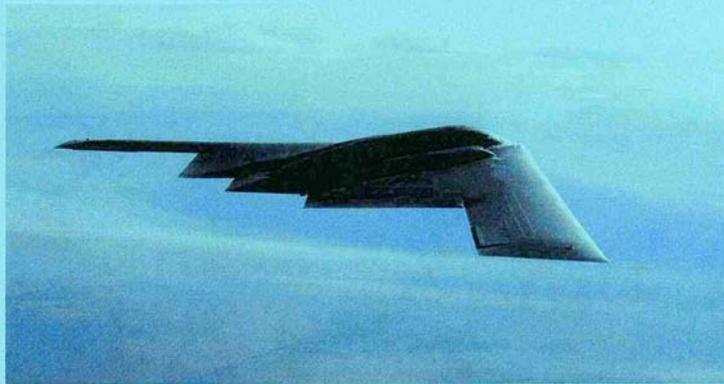
393D BOMB SQUADRON
509TH BOMB WING
WHITEMAN AIR FORCE BASE, MISSOURI

LOCATION: ANDERSEN AIR FORCE BASE, GUAM

DATE OF ACCIDENT: 23 FEBRUARY 2008

Initial ground contact occurred when the left wing tip hit the ground causing fracture damage to the wing tip and wing tip support structure. The aircraft continued upwind then descended to hit the ground with the nose gear and then the left main landing gear. Upon ground impact, the left main landing gear separated from the aircraft releasing fuel. This caused a fireball to travel upwind scorching an area of approximately 29,517m². The left main landing gear rested 475m from the final position of the aircraft. The bomb bay and nose landing gear doors, located at 350 – 400, from the aircraft, showed signs of physical damage with little or no scorch markings. Ground scars show the aircraft came to rest 717m from initial ground contact. The pilot (left) seat rested 458m from the aircraft. The co-pilot seat rested 431m from the aircraft. The hatches were located 568m and 578m from the aircraft. The debris field was comprised of random pieces and fragments of composite materials ranging in size and shape with very few metal pieces found. Most of the aircraft structure remained intact but with severe impact damage as it came to rest on its bottom outer mold line. The survey determined the debris field area was 18,964m².

At take off, the aircraft contained approximately 20,735 gallons of fuel. As the aircraft came to rest, pooling fuel burst into flames. Burning reached a steady state level within seconds of impact and continued for approximately 4-6 hours before transitioning to a cool down phase. The complete combustion event did not end until day two and possibly three. In total, the fire department used 83,000 gallons of water containing 2,500 gallons of aqueous film-forming foam (AFFF) with not much success in completely putting out the final combustion stage. Low hydrant pressure in the area required fire trucks to leave the scene to get more water. Fire trucks ran out of water approximately 4 or 5 minutes into the scenario then had to ferry back and forth to refill. A constant supply of water to completely cool the aircraft and shorten the overall response time was needed.
